Technical Bulletin:	6
Title:	Guidance on webbing handrails located along climbing inclines on inflatable play devices (slides)
Date:	10 <sup>th</sup> of November 2023

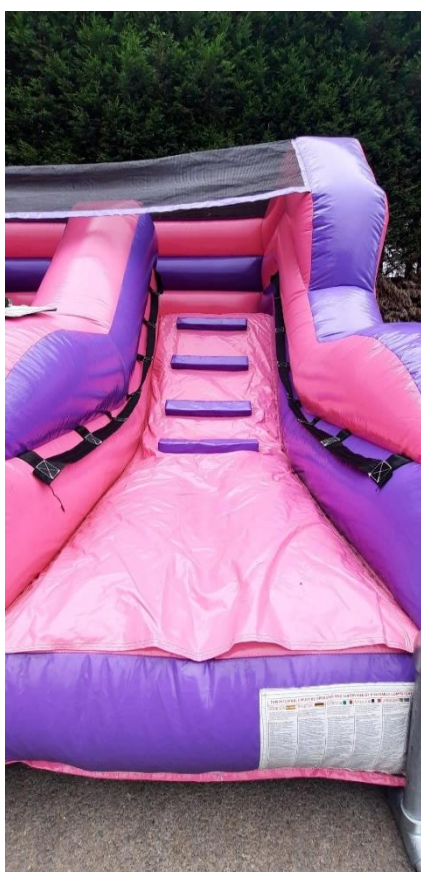
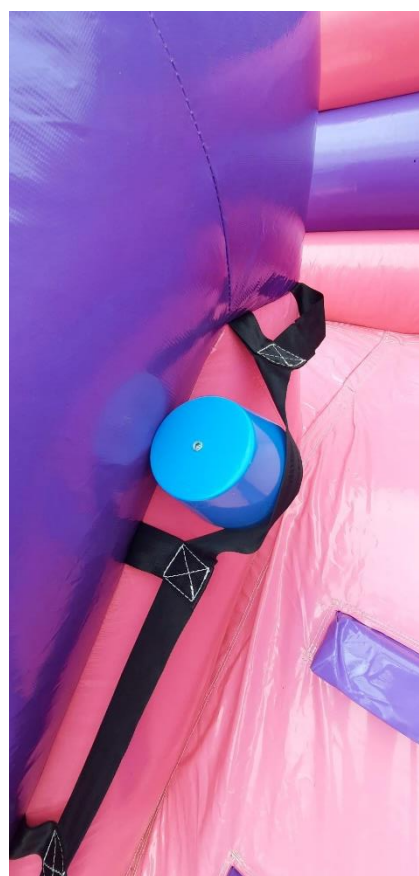
The inspectors found that the spacing between the stanchions allowed enough free play for the small head probe to pass between the webbing and the PVC panel to which it is attached. But would not allow the large head probe to pass through the same gap.

1. As per section 4.2.5.2 there are multiple completely bound openings created by the webbing handrail/banister and these have the potential to create a head and/or neck entrapment.
2. When considering the photographic evidence presented to the GCG these openings do form a head/neck entrapment when applying the requirements of sections 4.2.5.2A and D2.1.
3. Section 4.2.5.2 suggests an allowance for completely bound openings located on platforms with a lower edge less than 600mm above the platform on which it is located.

The webbing handrails/bannisters do not comply with BS/EN 14960-1 and do form a potential head, neck, or limb entrapment when all relevant sections of the standard are considered.

1. For future products, manufacturers could simply increase the number of stanchions tying the handrail back to the unit until the opening no longer allows the entry of the small head probe. The GCG would not recommend expanding the opening to allow the large head probe to pass through as the location of the opening on an incline would still present an increased risk to users.

2. The additional stanchions could be retro installed; however, this would be a complicated and costly solution.
3. The handrail could simply be removed. However, before doing this, manufacturers, inspectors, and repairers should carefully consider the risk to users should they slip or fall. Is this hazard significant in comparison to the risk presented by the handrail?

4. The handrail could be segmented to produce "Tabs" to which users could hold onto while climbing the incline. Of course, this would increase the strain associated with each "Tab" and may lead to seams failing earlier than expected.
