# Technical Bulletin 6

## Guidance On Webbing Handrails Located Along Climbing Inclines On Inflatable Play Devices (slides)

| Date: | November 2023 |

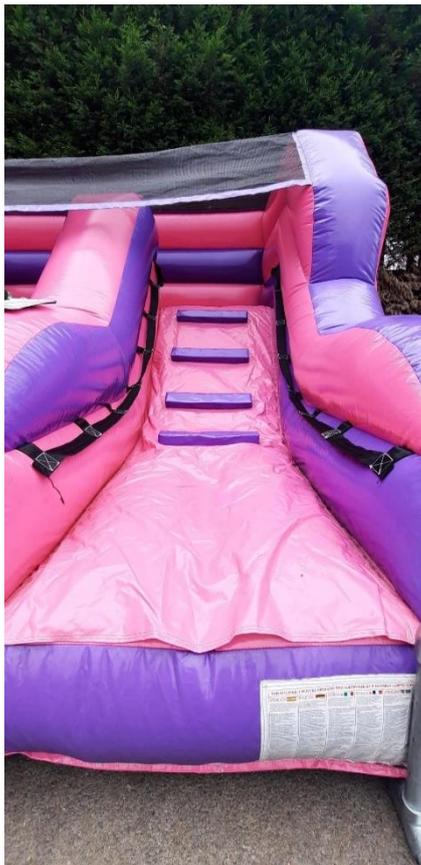
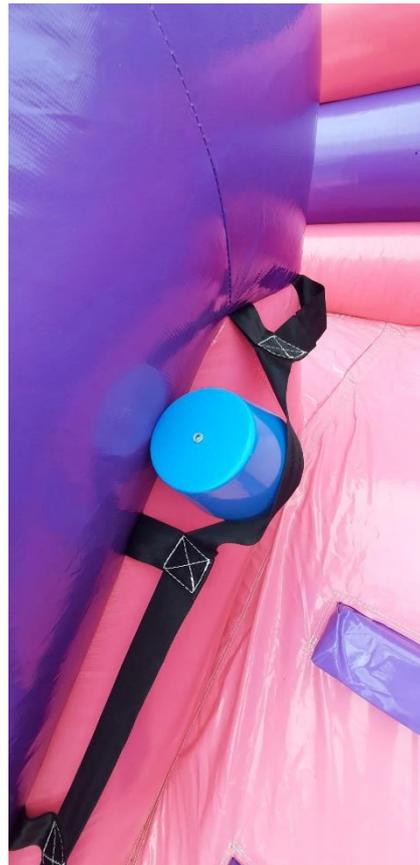
The inspectors found that the spacing between the stanchions allowed enough free play for the small head probe to pass between the webbing and the PVC panel to which it is attached. But would not allow the large head probe to pass through the same gap.

1. As per section 4.2.5.2 there are multiple completely bound openings created by the webbing handrail/banister and these have the potential to create a head and/or neck entrapment.
2. When considering the photographic evidence presented to the GCG these openings do form a head/neck entrapment when applying the requirements of sections 4.2.5.2A and D2.1.
3. Section 4.2.5.2 suggests an allowance for completely bound openings located on platforms with a lower edge less than 600mm above the platform on which it is located.

The webbing handrails/bannisters do not comply with BS/EN 14960-1 and do form a potential head, neck, or limb entrapment when all relevant sections of the standard are considered.

1. For future products, manufacturers could simply increase the number of stanchions tying the handrail back to the unit until the opening no longer allows the entry of the small head probe. The GCG would not recommend expanding the opening to allow the large head probe to pass through as the location of the opening on an incline would still present an increased risk to users.

2. The additional stanchions could be retro installed; however, this would be a complicated and costly solution.
3. The handrail could simply be removed. However, before doing this, manufacturers, inspectors, and repairers should carefully consider the risk to users should they slip or fall. Is this hazard significant in comparison to the risk presented by the handrail?

4. The handrail could be segmented to produce “Tabs” to which users could hold onto while climbing the incline. Of course, this would increase the strain associated with each “Tab” and may lead to seams failing earlier than expected.
