# TB11 – Hidden Entrapments within the play area

Document	TB011-100		
Number			
Release Date	10-03-2025	Version	1.00
Title	TB11 – Hidden Entrapments within the play area

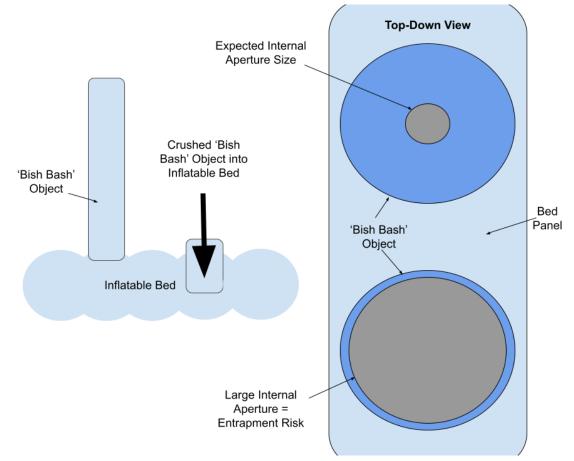
The cause of the incident was due to both low pressure within the bish bash object and the size of the aperture in the bish bash object's base. In this incident, the aperture was of a similar circumference of the bish bash object. This enabled the bish bash material plus user's limb to pass through the aperture into the bed. The exact root cause is unknown, and it is not known at what pressure the inflatable was operating at.

The outcome is to ensure that part of the body is unable to enter the bed through an object in the play area to cause an entrapment, rather than a stipulated manufacturing process. For example, in figure 1 it shows a smaller aperture which is created by a reduced hole in the inflatable bed. Objects may also be stopped from entering the aperture by using criss-cross webbing or alternative manufacturing techniques to prevent entrapment.

Figure 1: Illustration of the incident and cause

Another consideration is the pressure within the inflatable object. If the object is sufficiently pressurised to mechanically prevent it being crushed into the inflatable bed, this also achieves the outcome of preventing the entrapment.

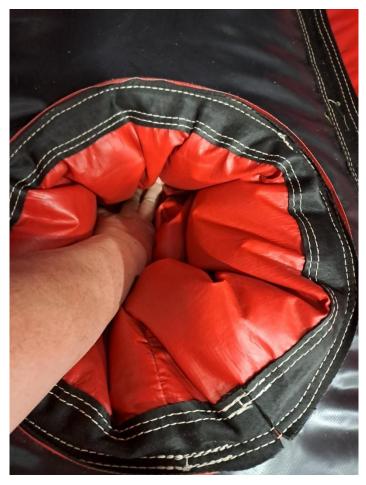
Figure 2: Example of a crushed inflatable object being pushed into the bed of the device

All controllers who operate devices which contain inflatable objects within the play area and are connected to the bed of the inflatable must check the ability of the object to resist the user's weight and interference during use. If the object can be 'crushed' by a user, check whether the object resists the ability for a user to be able to push the object into the bed of the inflatable (see Figure 2).

If the device is operating at the correct pressure, and you believe the aperture into the object may enable an entrapment issue to occur, you should contact the manufacturer in the first instance.

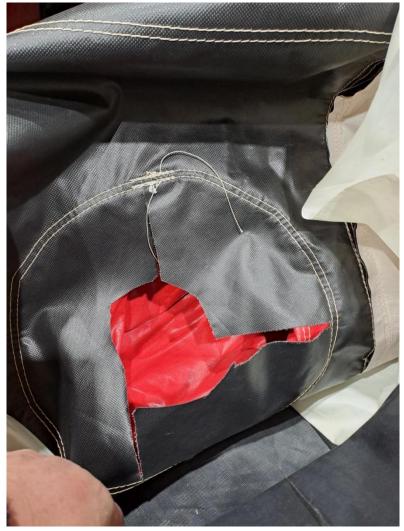
If the small head probe pushes the object through an aperture into the inflatable bed, the device must be failed due to the risk of entrapment for users.

Figure 3: Failed aperture enabling object being pushed into the bed of the device

The inflatable should be failed under the entrapment section of the inspection report, with sufficient detail and photos to help show the risk you have identified. The manufacturer should be contacted for advice before repairs are completed.
